2017 Hurricane Harvey Deployment
Arkema Facility Response
8/31/2017 1:45:27 PM

***2017 ASPECT Preliminary Report
Arkema Plant Response
Crosby, TX***

***August 31, 2017
0600 hrs to 1300 hrs***

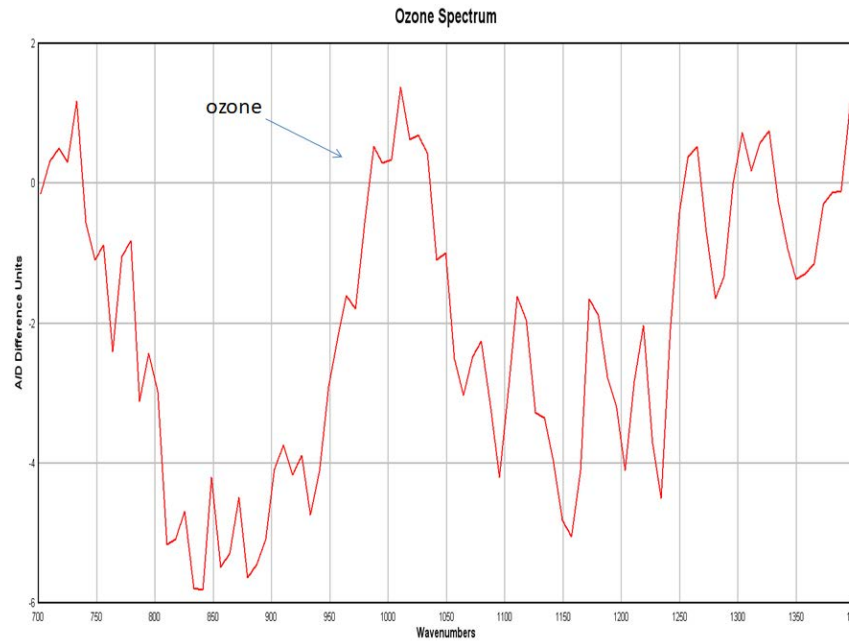
The ASPECT technical reach back team manually inspected and analyzed 21,000 FTIR spectral measurements from the morning sortie. No significant deviations or anomalies were associated with the explosion and subsequent fire, however ozone was detected which was likely created during the fire.

Figure 8: Passive (remotely detected at 2,800 ft AGL) FTIR spectra showing ozone, a commonly occurring air pollutant. This confirms that the instrument was operating properly.
